In re Flint Water Cases,
No. 16-cv-1044

Supplemental Report of Dr. Larry L. Russell

October 18, 2022

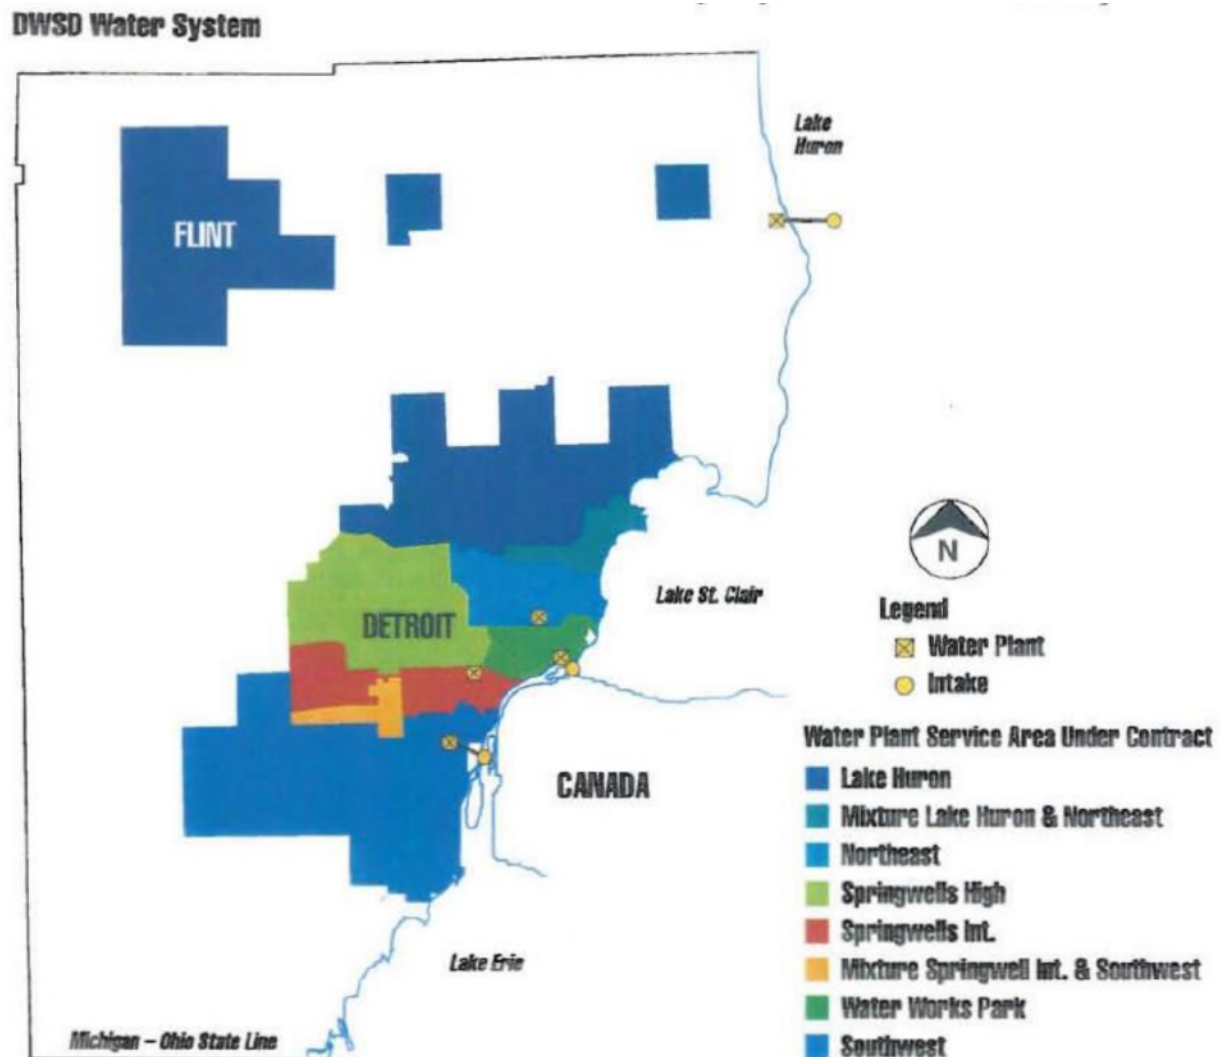
Figure 4.1-1: DWSD Lead and Copper Corrosion Control Optimization Study (1994), Figure ES-1: DWSD Water System.

Similarly, it is equally inconceivable that the LAN engineers were not aware of this report written in 1994, and which incorporated the City of Flint as a part of the DWSD distribution system as shown on Figure 4.1.1 (Figure ES -1 from the TYJT report). If both of the City's water quality engineering consultants were unaware of the TYJT OCCP study and report and the DWSD corrosion control program, then they did not adequately conduct their due diligence prior to providing advice to the City of Flint on water quality and it resulted in them both practicing below the requisite Standard of Care.

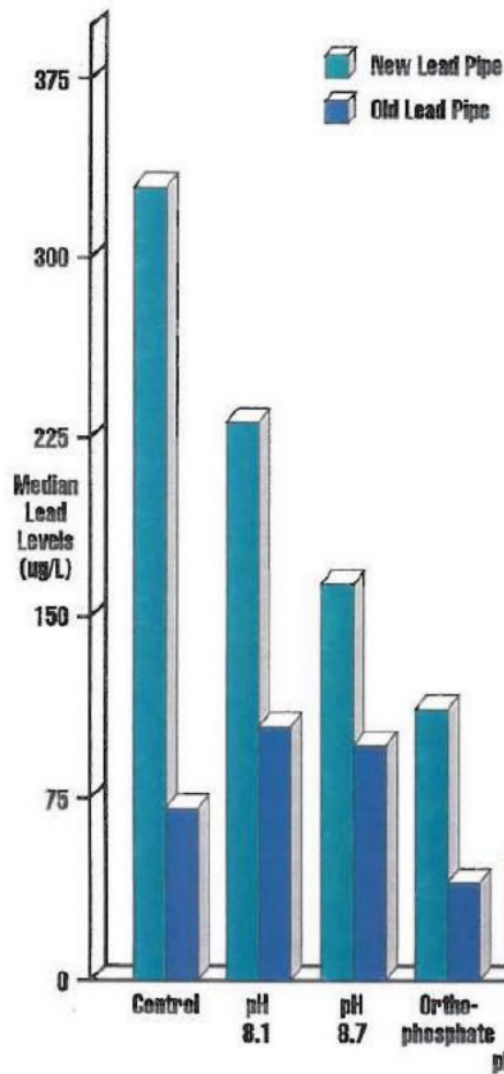
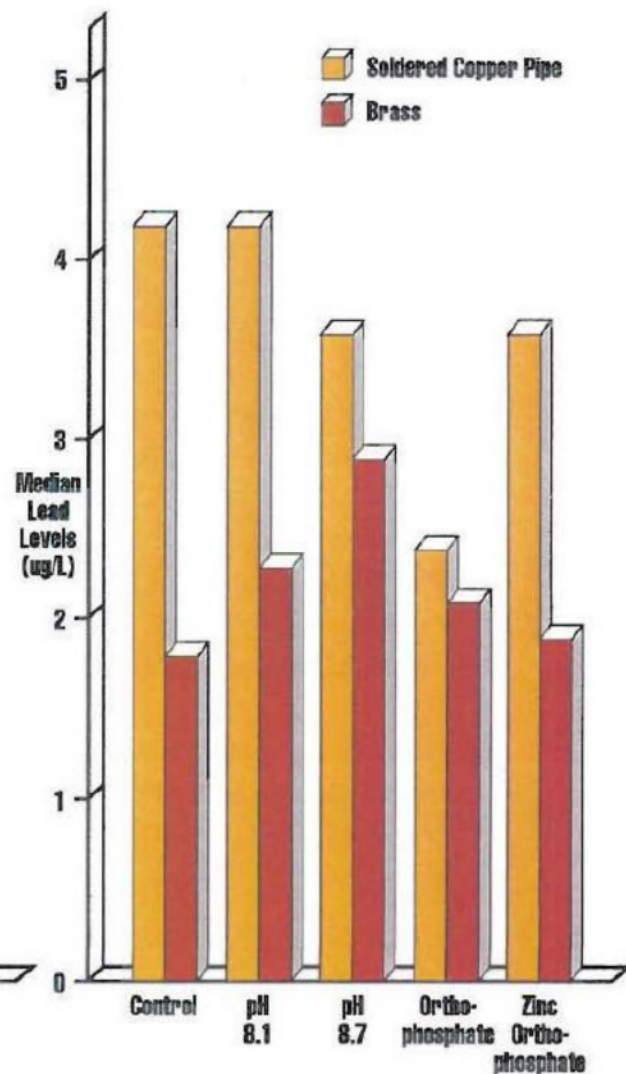
Figure 4.1-4: *DWSD Lead and Copper Corrosion Control Optimization Study (1994)*, Figure ES-5 and ES-6: Measured lead levels from lead pipe (left), brass and soldered copper pipe (right) during corrosion control optimization testing.

Figure 4.1.4 demonstrates the effectiveness of the chosen chemical addition, Orthophosphate, in controlling lead corrosion with the treated Lake Huron water. Figure 4.1.5 demonstrates the effectiveness of the chosen chemical addition, Orthophosphate in controlling copper corrosion with the treated Lake Huron water. After a substantial pipe loop testing of these alternatives, the TYJT team correctly recommended a treatment strategy using phosphoric acid to add orthophosphate at a recommended dose of 1.2 mg/L as P, initially, and reducing it to a sustained dosage of 0.4 mg/L, as the optimal DWSD corrosion control treatment in their 1994 study (ES-9).

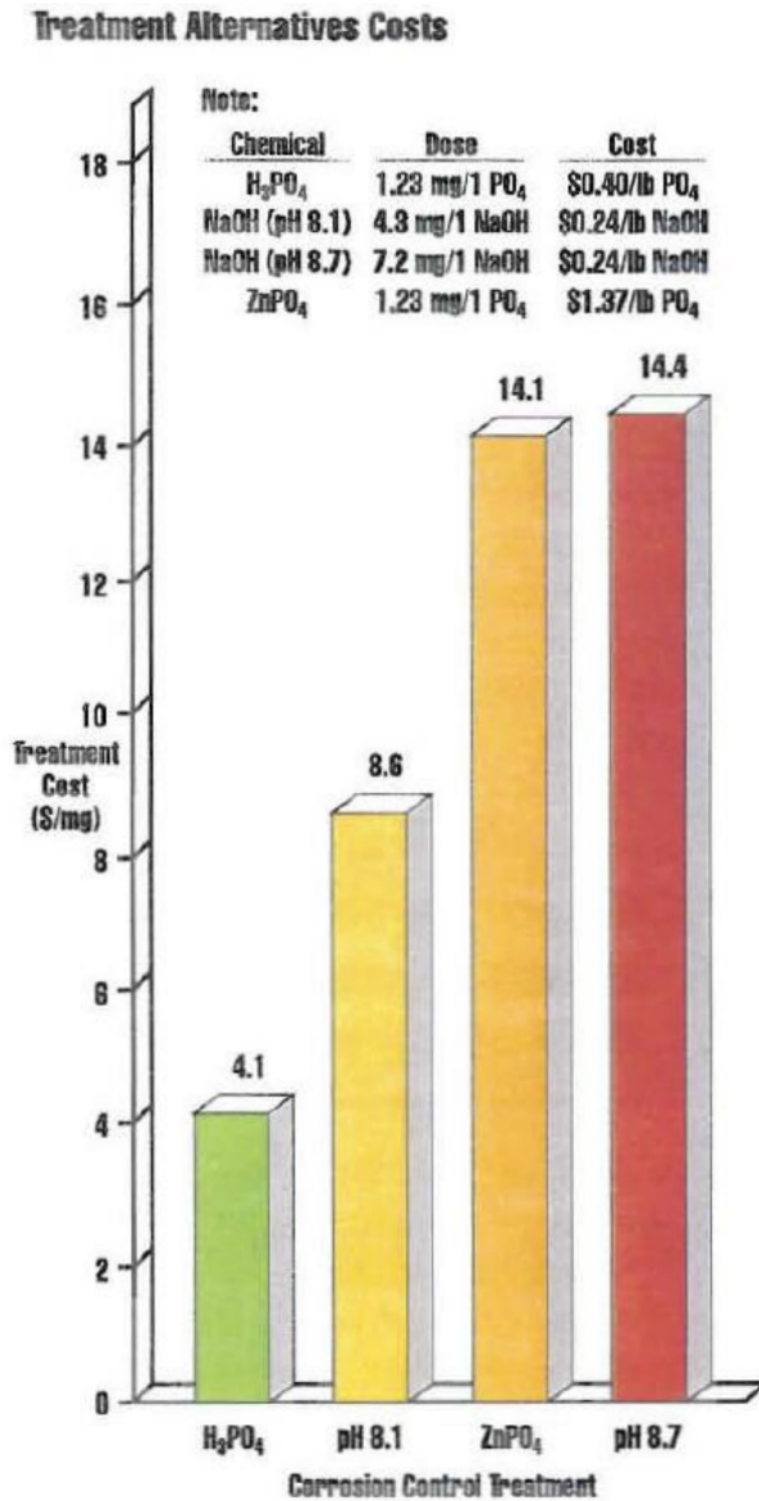
Figure 4.1-6: *DWSD Lead and Copper Corrosion Control Optimization Study (1994)*, Figure ES-8: Treatment Alternative Costs.

The TYJT team also indicated that the cost of dosing with phosphoric acid added an operating cost of \$0.87 annually per household in 1994 USD (\$1.50 in 2014) which is de minimis in the grand scheme of the cost of the Flint Water Crisis in damage to the residents’ plumbing, money, and human health impacts related to the corrosion damage incurred during the Flint Water Crisis. The overall system costs of the various treatment alternatives are shown on Figure 4.1.6.

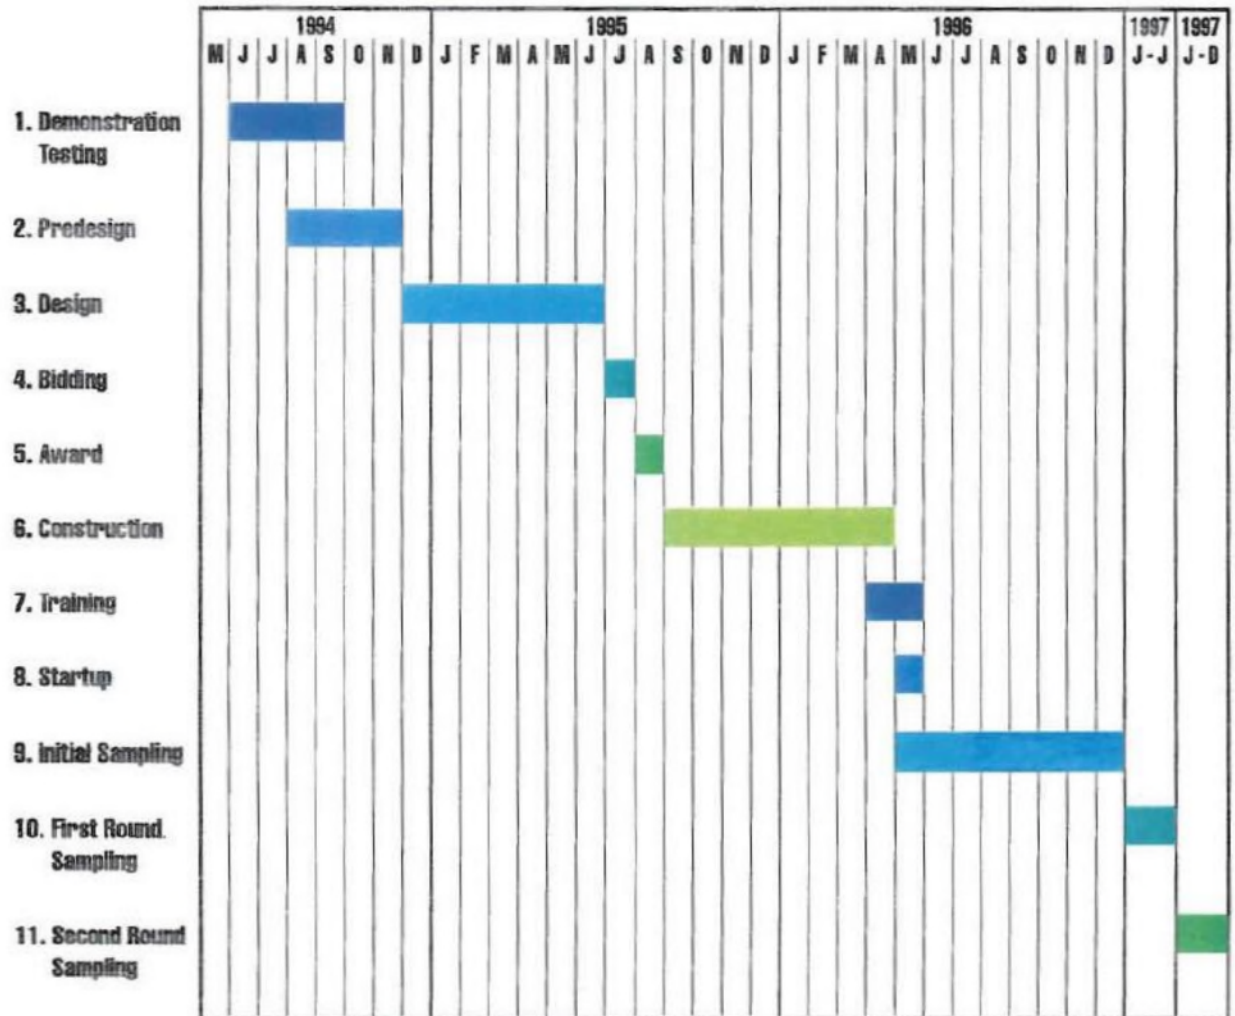
Figure 4.1-8: *DWSD Lead and Copper Corrosion Control Optimization Study (1994)*, Figure ES-10: DWSD Corrosion Control Implementation Schedule.

Figures 4.1.7 and 4.1.8 respectively report the relative performance/effectiveness of various corrosion control strategies and the time that was invested to properly address the development of an OCCT for DWSD (over three years). This information would have been useful for LAN and the City of Flint to recognize how long it takes to properly conduct an OCCT, which should have been a red flag regarding
